Final Report

Clayburn Creek Integrated Stormwater Management Plan - APPENDICES

May 2012

Appendix A – Watershed Overview

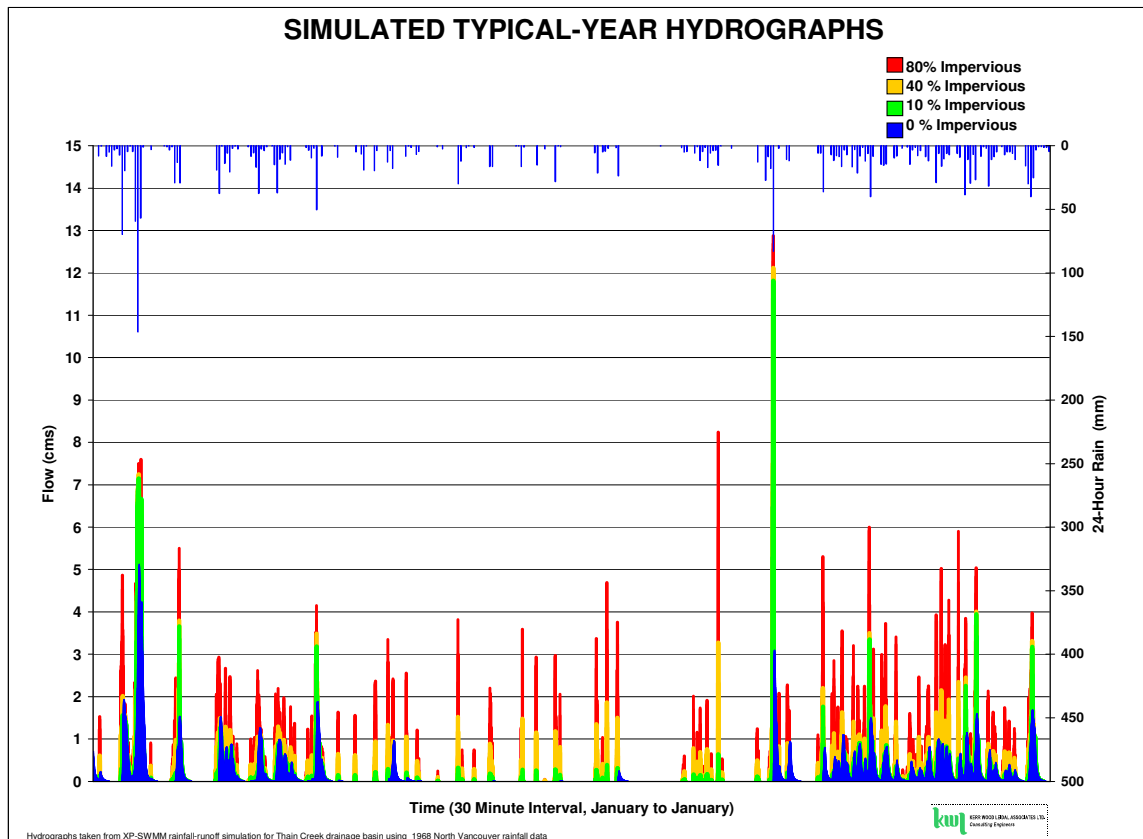
Figure A-1: Simulated Typical-Event Hydrograph for Levels of Imperviousness

Prior to land development, minor rainfall events do not yield surface runoff. However, because of increased impermeable area, surface runoff from these minor storms is produced after land development. This is clearly shown in the typical-year hydrograph for various levels of development (refer to following figure).

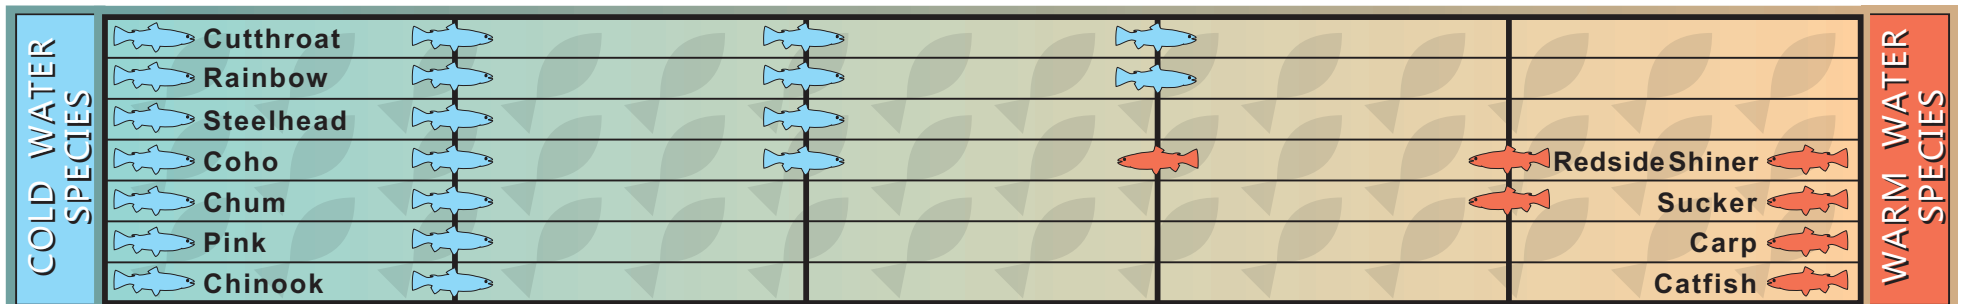
INCREASING URBANIZATION (NO BEST MANAGEMENT PRACTICES)

PROPORTION OF IMPERVIOUS LAND AREA (%)

EFFECT ON WATER QUALITY AND AQUATIC HABITAT

EFFECT ON TYPICAL YEAR HYDROGRAPH

NUMBER OF STORM EVENTS AT OR ABOVE PREDEVELOPMENT MEAN ANNUAL FLOOD

EFFECT ON DIVERSITY AND ABUNDANCE OF THE FISHERIES RESOURCE

EFFECT ON BIOTIC INDICATORS FOR BENTHIC ORGANISMS

The increased frequency of higher runoff rates and volumes causes watercourse wear and tear. The Mean Annual Flood (MAF) is a key parameter because watercourses tend to be in equilibrium under the MAF. The consequence of increasing the MAF is channel erosion until the channel widens or deepens to the point of establishing a new equilibrium. Erosion and sedimentation processes then progressively eliminate aquatic and riparian habitat.

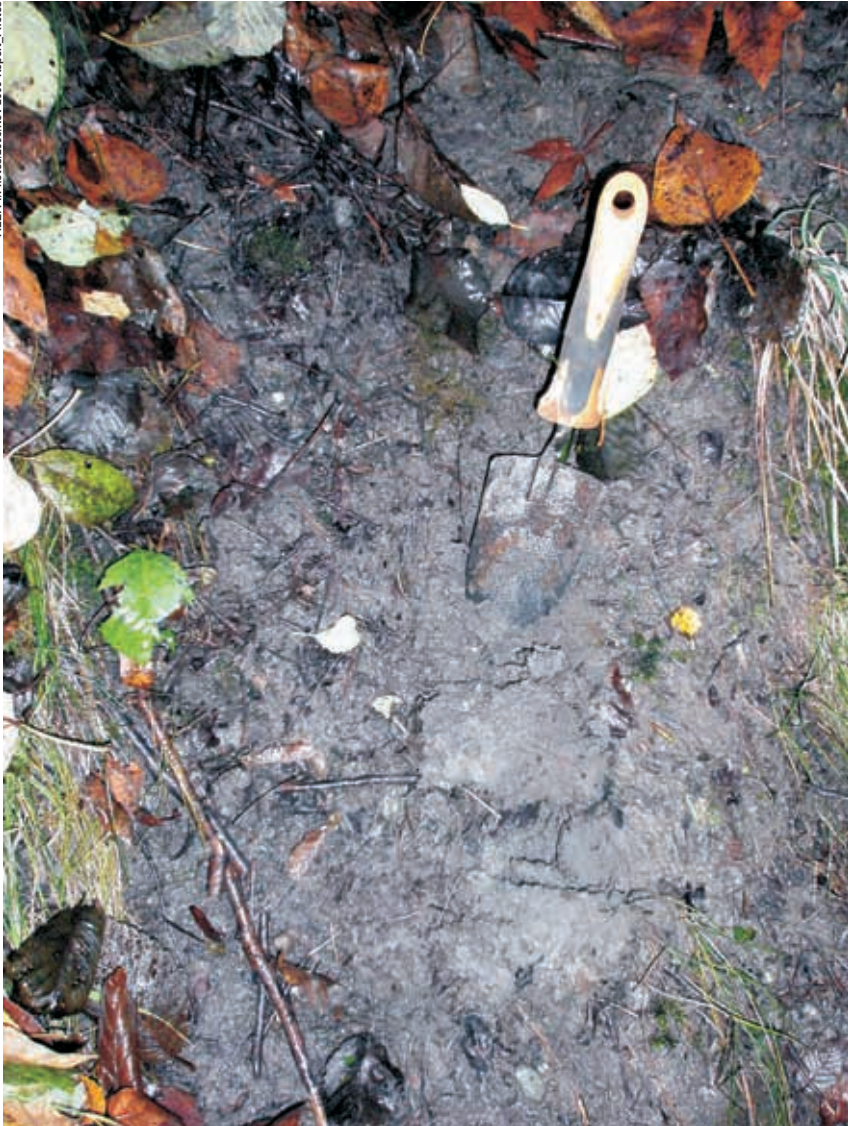
Photo 1.
Saturated till exposure on creek embankment in McKinley Park.

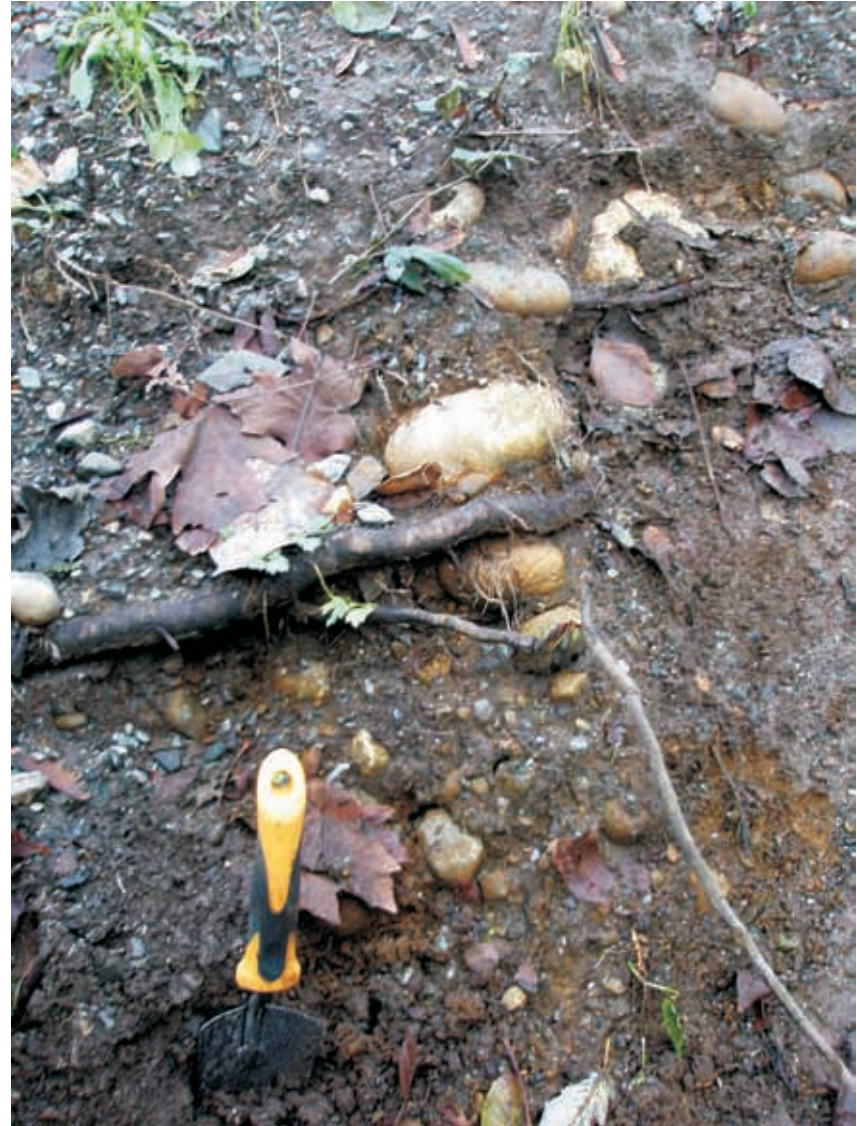
Photo 2.
Silty sand and gravel on Stoney Creek channel bank.

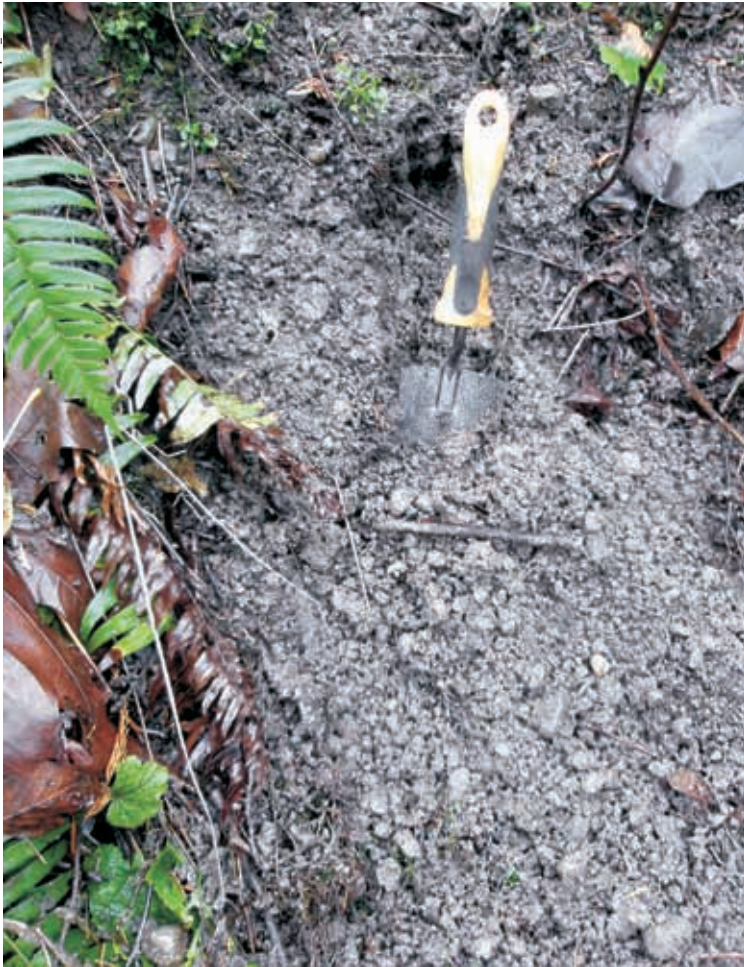
Photo 3.
Sand and gravel profile on ravine bank in Straiton Park.

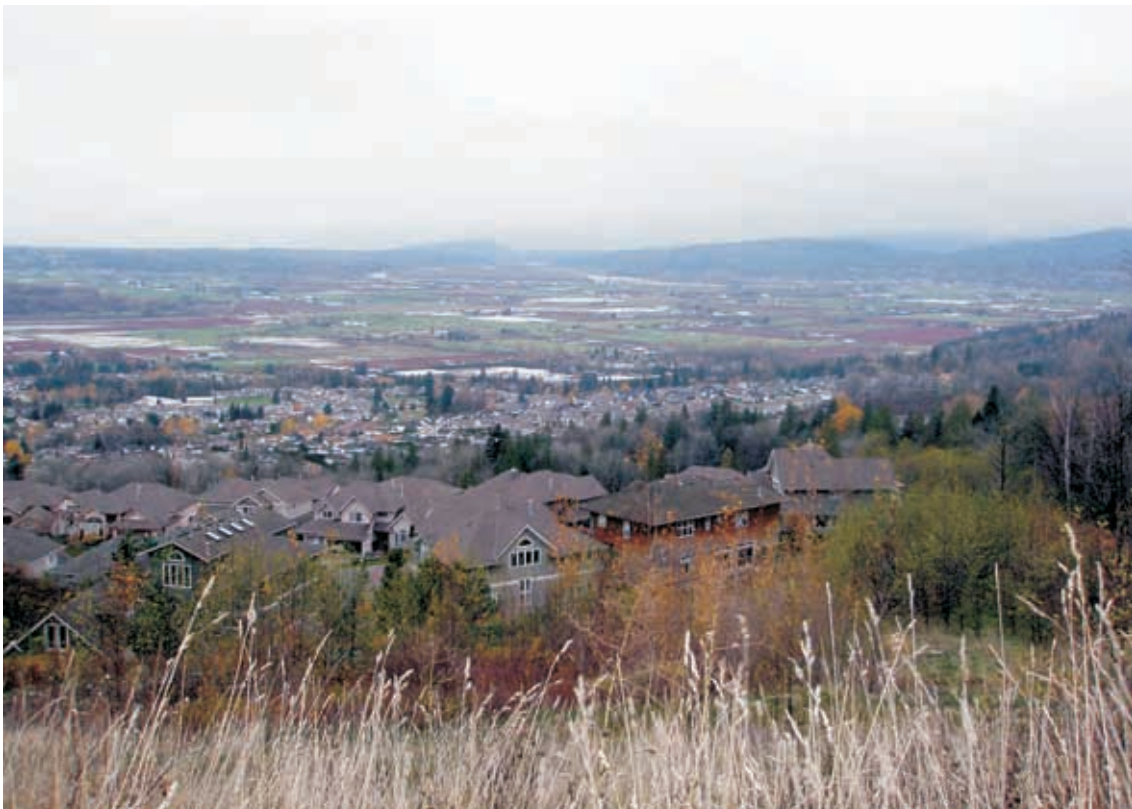
Photo 4.
Looking northwest towards Matsqui Slough floodplain from Westview Boulevard. High water table conditions in Lowland Area evidenced by surface ponding in distance.

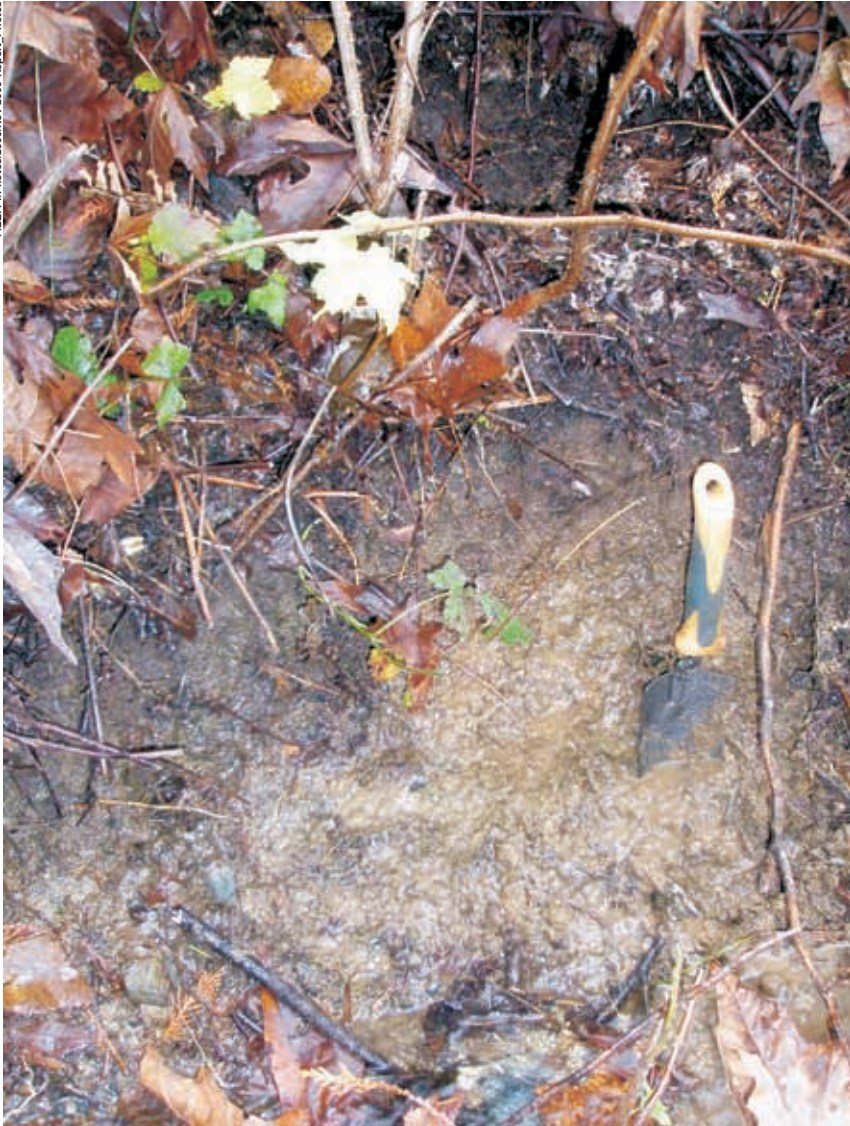
Photo 5.
Saturated clayey till at Dawson Road and Charlie Spruce Place.

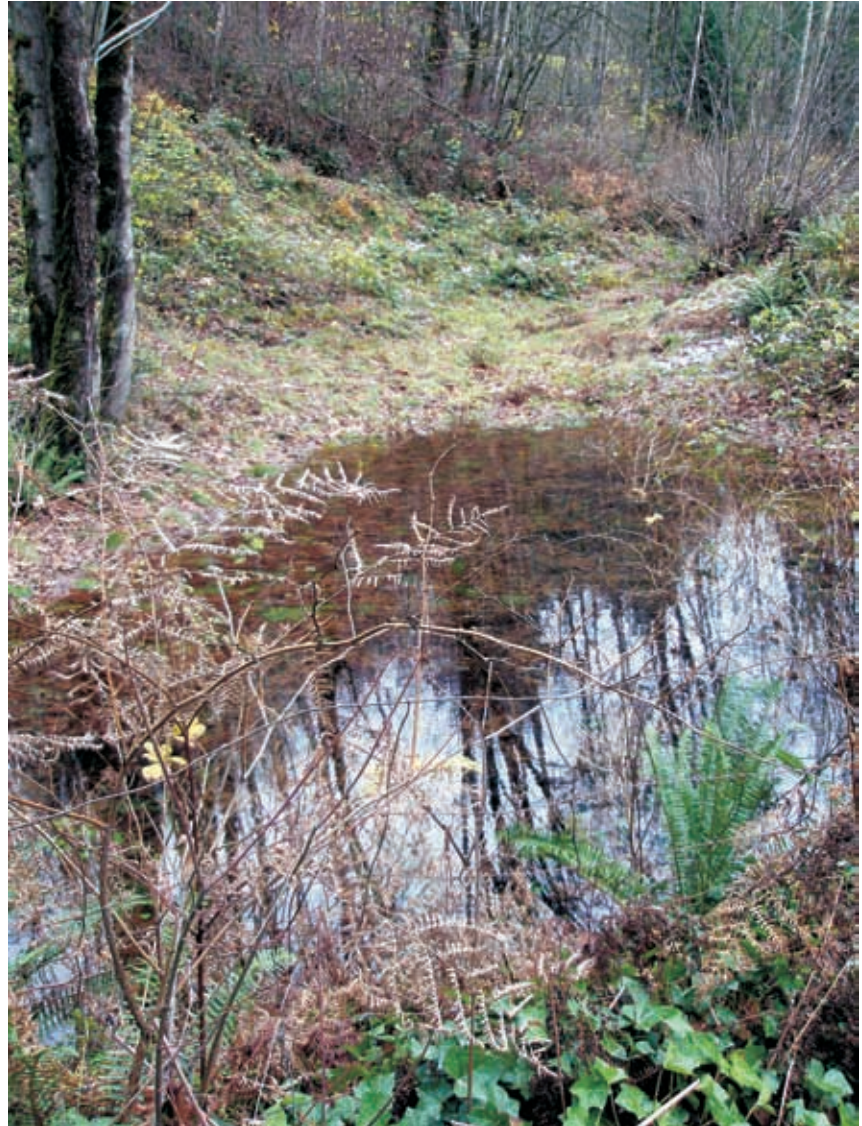
Photo 6.
Spring near Charlie Spruce Place.

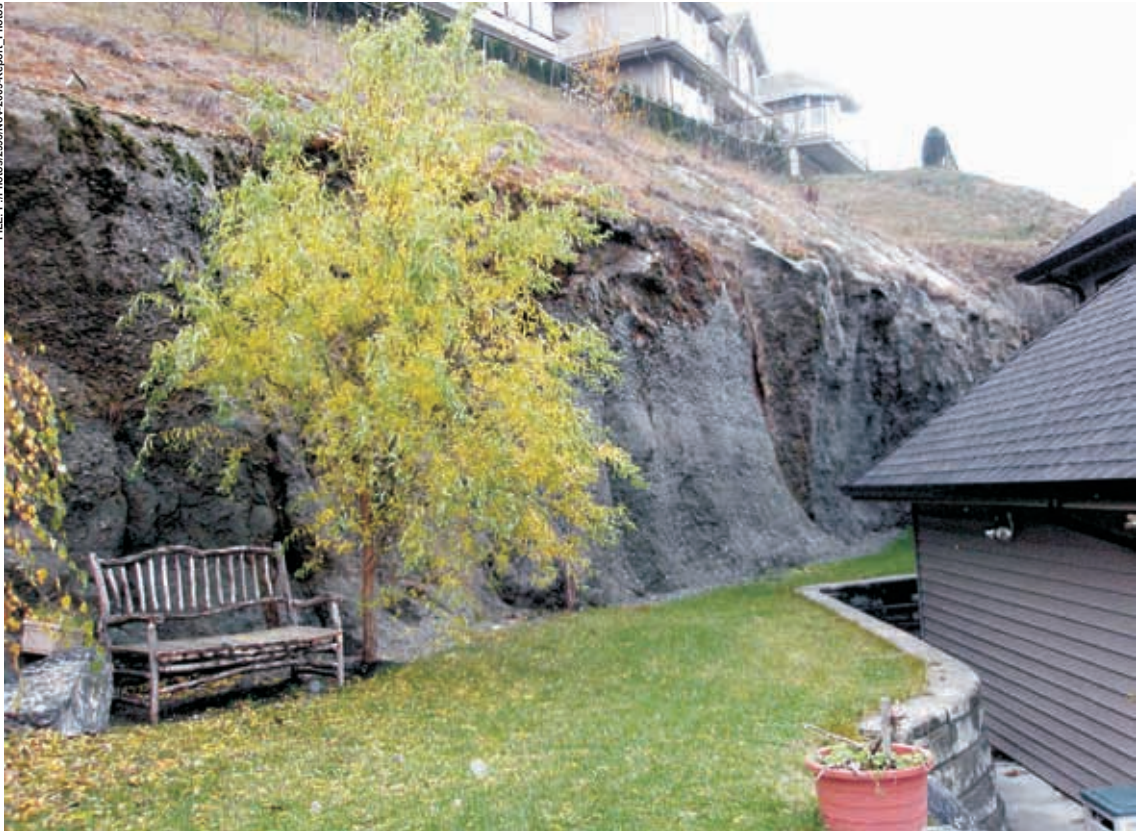
Photo 7.
Sandstone face with minimal overburden on Westview Blvd.

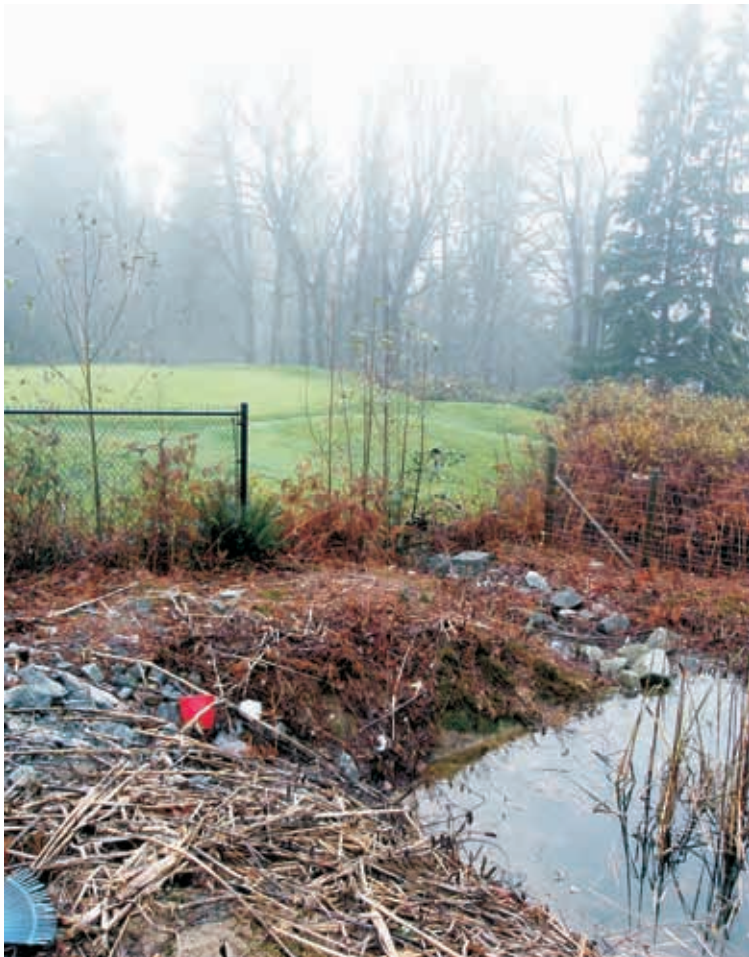
Photo 8.
Soak-away pit at north end of cul-de-sac adjacent to the east of Golf Course.

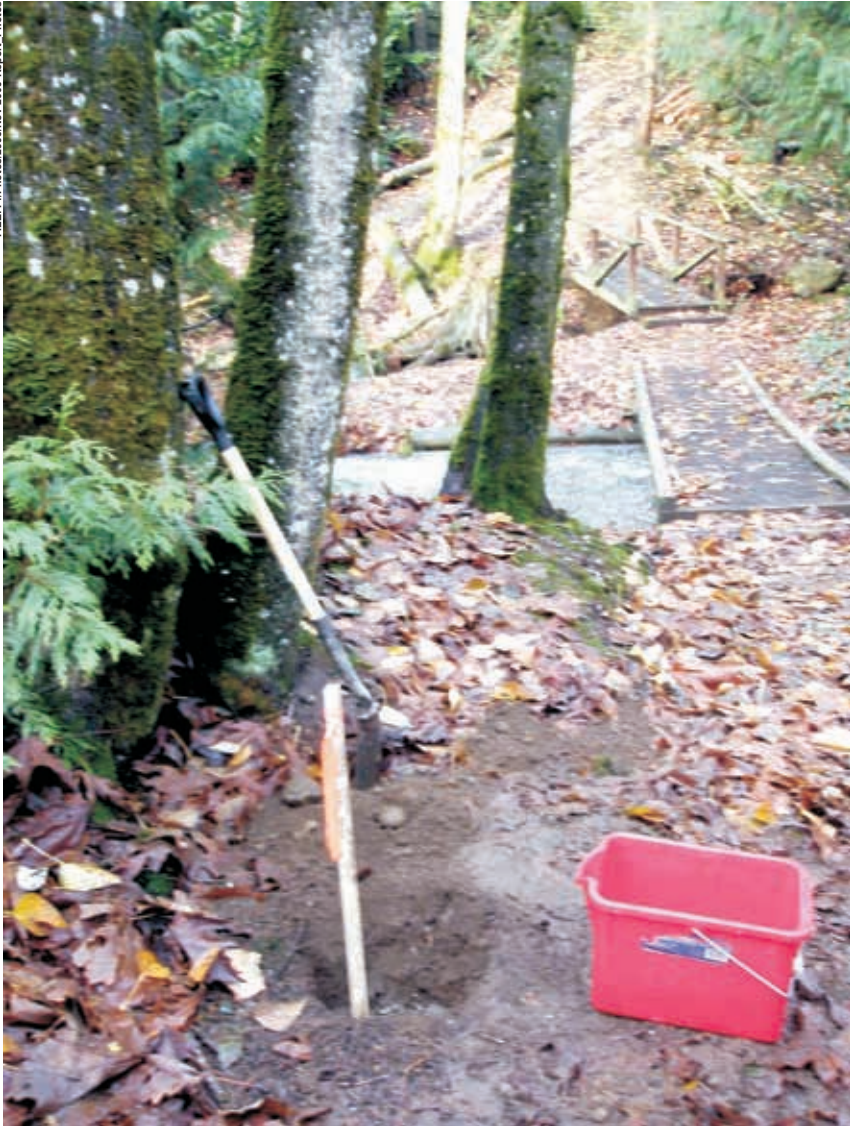
Photo 9.
Percolation test set-up at McKee trial (Location 3).

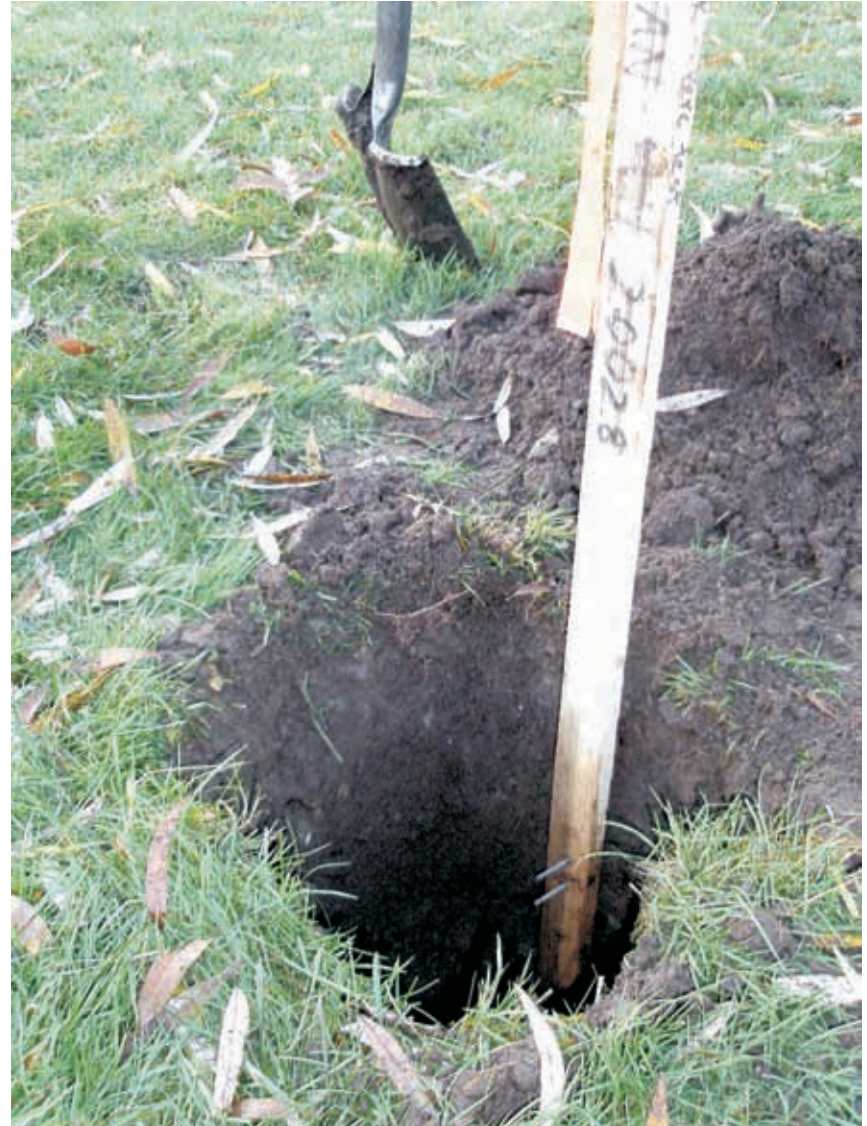
Photo 10.
Percolation test set-up at north end of Bateman Park (Location 5).

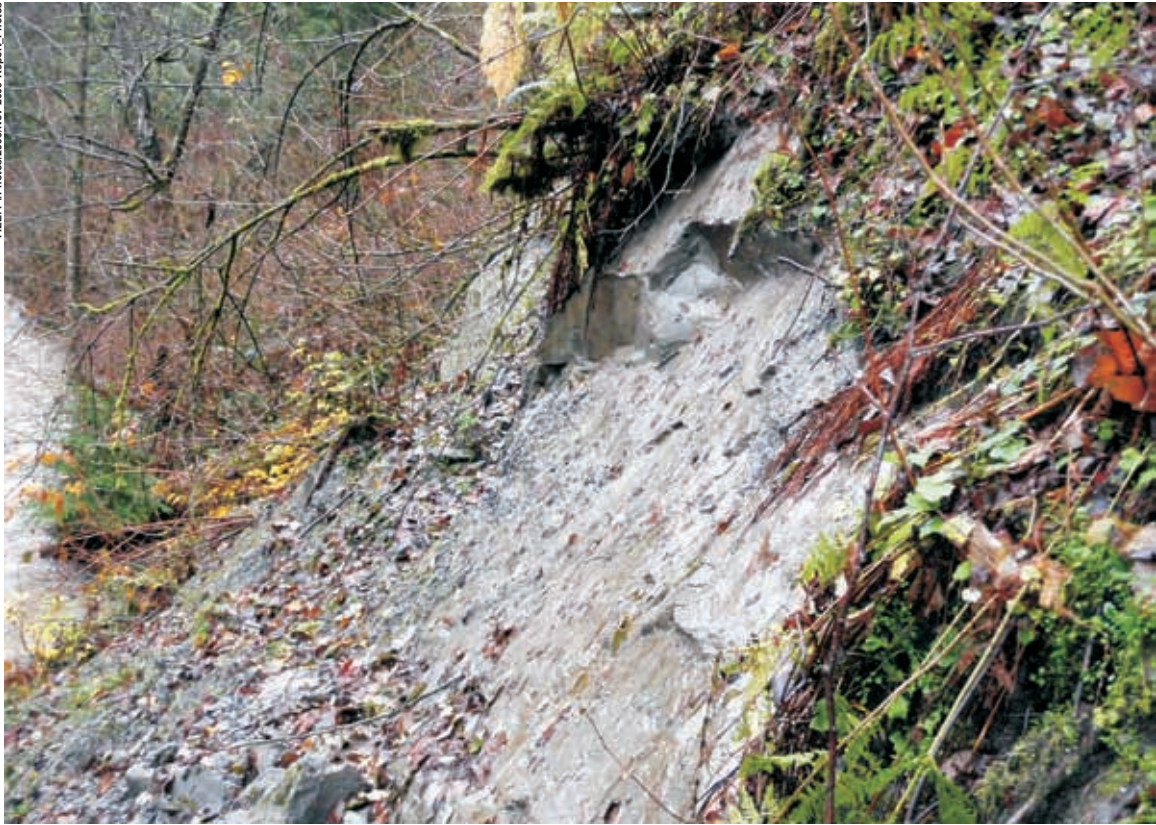
Photo 11.
Clayburn Creek eroding toe of slope. Note blocks of fine-grained till or glaciomarine silt and clay spalling off scarp.

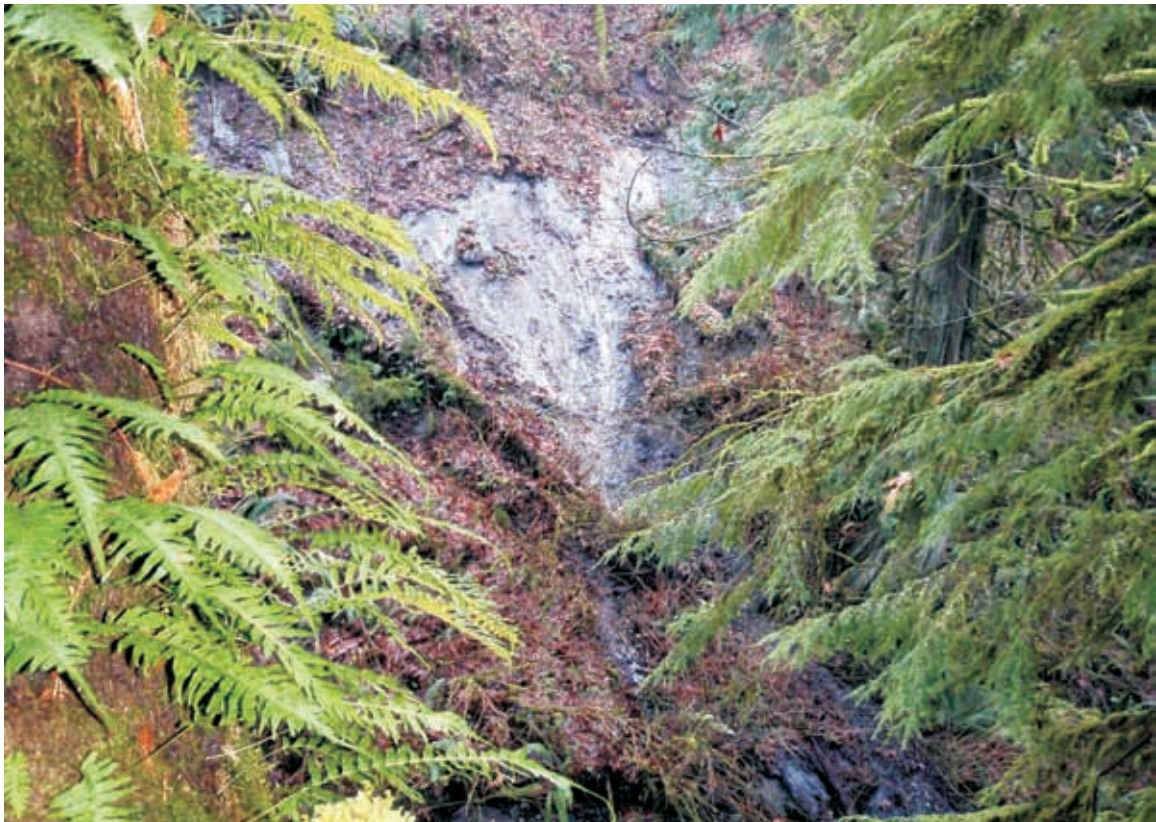
Photo 12.
View of recent debris slide on lower ravine slope immediately above Clayburn Creek.

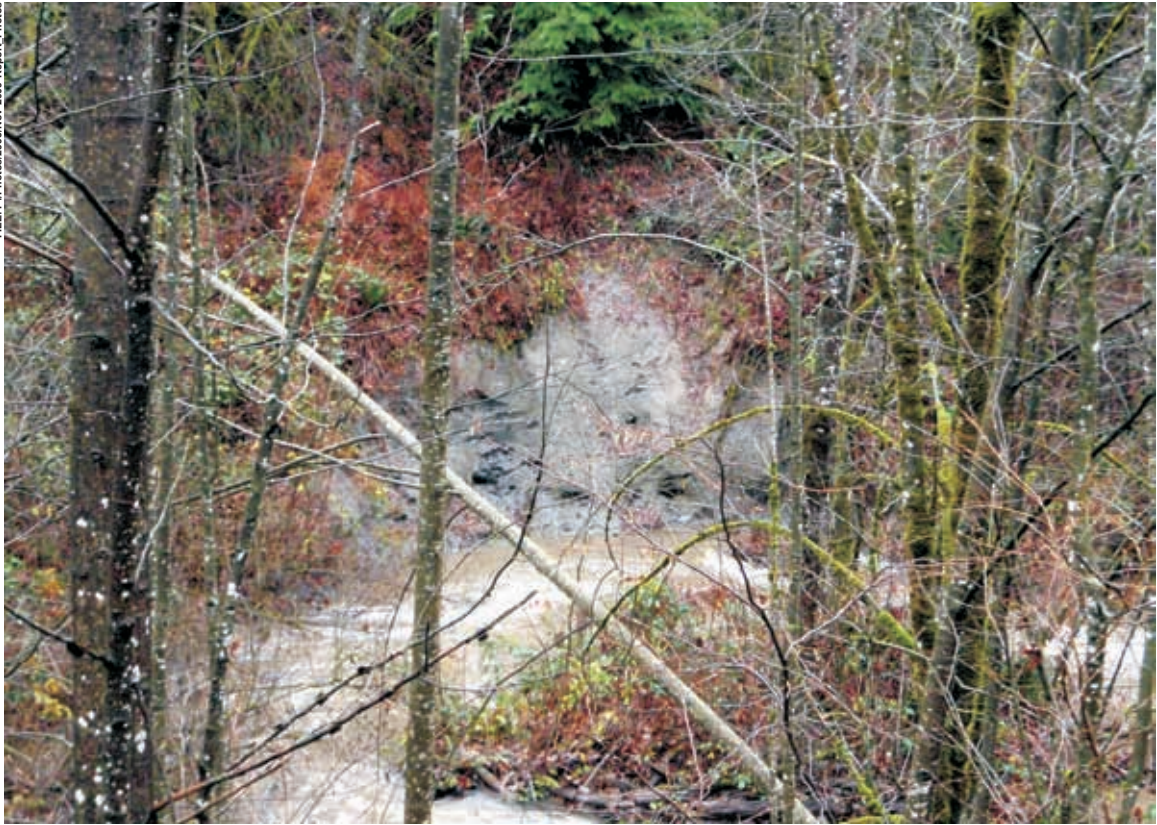
Photo 13.
View from Straiton Road of erosion of toe of ravine slope along Poignant Creek.

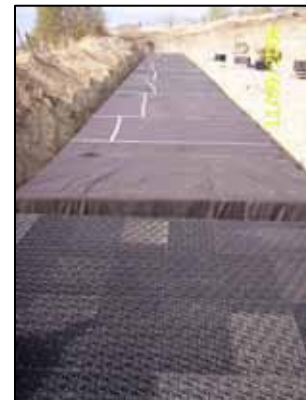
Sub-Surface Infiltration

Sub-surface facilities must be located at least 0.5 m above the level of the water table so that they can discharge through the sides and bottom of the structure and will not merely store infiltrated groundwater. Generally, the deeper an infiltration facility is located, the less-effective it will be. Subsurface infiltration facilities can be as simple as a trench filled with clean, free-draining rock that is protected from soil by a permeable membrane. There are numerous products available commercially for subsurface infiltration as well.
